**PRE-ASSEMBLY INSPECTION OF THE PIPE:** Responsibilities for the Fusion Technician on-site include looking for identifiable manufacturing related anomalies and/or damage caused by common storage and material-handling related issues. This helps the Fusion Technician avoid non-installer related issues that can have a serious impact on the successful completion of an electrofusion joint!

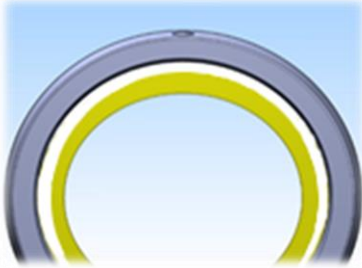
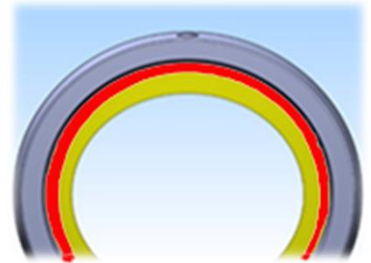
## Out-of-Spec Pipe

Electrofusion Couplers are manufactured to very tight ASTM tolerances. If the area where the coupler is being installed does not conform to the OD requirements of ASTM F714 in the area the EF Coupler is being installed; the melt flow being created in the fittings' fusion zone will be unable to effectively close the excessive gap in the annular space between the fitting and the undersized pipe surface. The result will be a loss of required interfacial pressure building up inside the fitting and could result in a failed fusion joint.

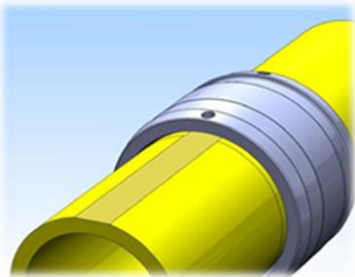
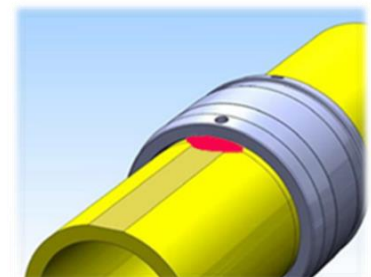
## Flat Spots

Flat-Spots and other surface anomalies are issues related to the manufacturing process. Damaged pipe surfaces can also be the result of improper transportation and handling, or from mishandling during warehousing and storage. If flat spots, unusual surface anomalies, or damaged spots exist in the area the EF Coupler is being installed, that exceed 10% of the minimum required pipe wall thickness; those areas must be cut back to where the pipe surface is in an acceptable condition and the pipe OD falls within tolerance.

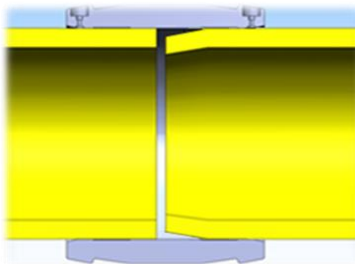
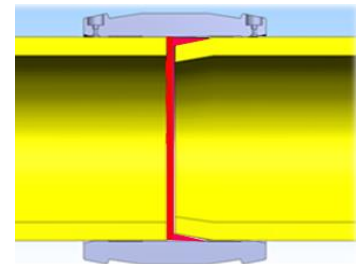
## Excessive Toe-In

Excessive Toe-In on the end of a pipe where the EF Coupler is being installed, can create an excessive gap in the center cold-zone of the EF Coupler being installed. If the gaps in the center cold-zone are too large, it may not be possible for the required interfacial pressures to buildup in the melt pool, and the result will be a sudden and excessive loss of interfacial pressure and molten material. If an excessive toe-in condition exists, the pipe end must be cut back to a point where the toe-in condition is removed.

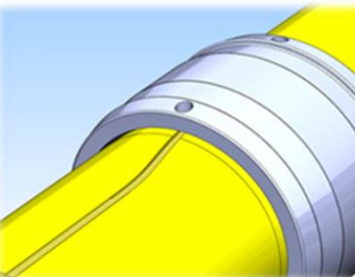
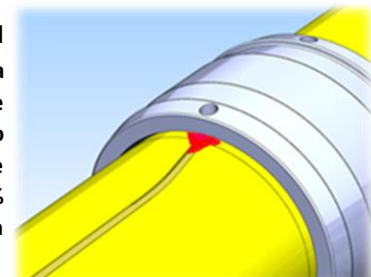
## Gouges

Gouges are a result of transportation, handling, and construction site issues. If gouges are found in the area where the EF Coupler is being installed that exceed 10% of the required pipe wall thickness, the pipe must be cut back to where the pipe surface is in an acceptable condition and the pipe OD falls within tolerance. Gouges that do not exceed 10% of the pipe wall thickness, may require extra attention when preparing the surface of the pipe.

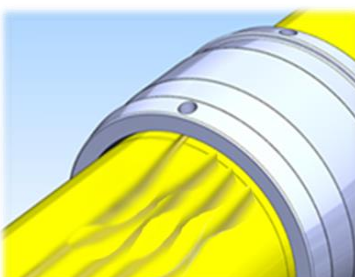
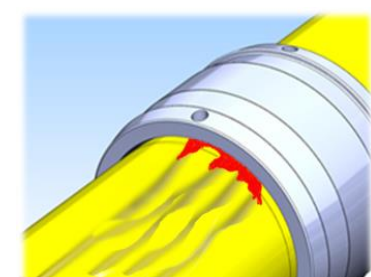
## Scratches

Gouges are a result of transportation, handling, and construction site issues. If excessive scratches are found in the area where the EF Coupler is being installed that exceed the 10% of the minimum required pipe wall thickness, that section of pipe must be cut back to where the pipe surface is in an acceptable condition and the pipe OD falls within tolerance.

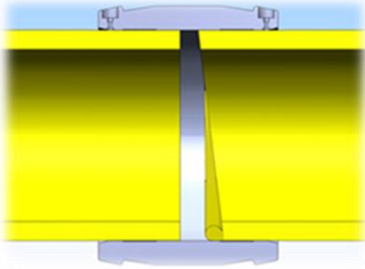
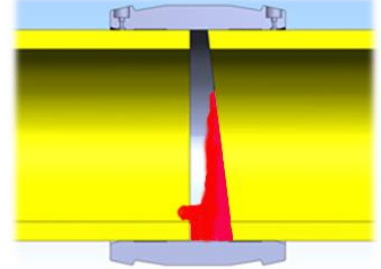
### Pipe Ends Mis-Cut

Pipe ends must be cut straight and square. Anything exceeding the acceptable +/- 3 degree deviation is considered a mis-cut assembly and may not be able to ensure full coverage of the heating coils and can result in an excessive gap that falls outside of the effective area of the center cold zone to contain the melt flow.

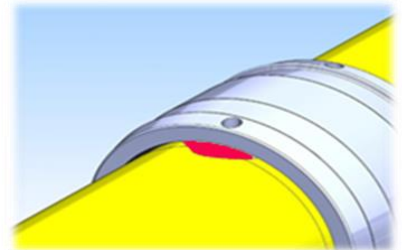
### Failure to Re-Round

Out-of-round pipe can create excessive gaps in the area where an EF Couplers is being installed. As polyethylene heats up, it expands and closes the gap between the pipe surface and the fitting. If there is a gap in the fusion zone that exceeds more than the expansion of the material can close, the result will be la loss of interfacial pressure, and the expulsion of molten material at the outside ends of the coupling.

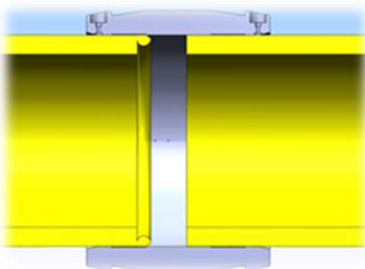
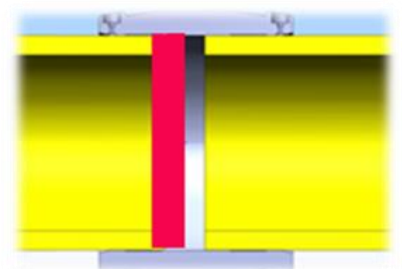
### Pipe End Short-Stubbed

Pipe ends not properly inserted all the way into the center of the EF Coupler being installed, is called a Short Stub. As the melt pool expands in the fusion zone, molten material will flow over the exposed pipe around the short-stabbed area. The result will be uncontained movement of the melt flow that will cause shorting in the fusion coil and rapid over heating in the fusion zones.

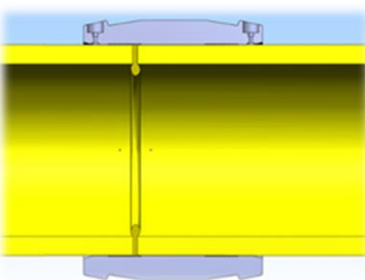
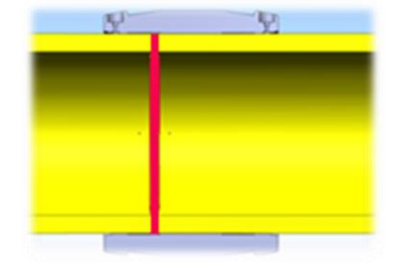
### Pipe End Mis-Stubbed

Pipe ends inserted beyond the center cold-zone of the EF Coupler being installed, causes the other side to be under inserted. This is called a Mis-Stub. As the polyethylene heats up and the melt pool expands, material will push through the gaps in the mis-stabbed area where the pipe ends meet. The result will be an uncontained movement of the melt flow that will cause shorting in the fusion coil and rapid over heating in the fusion zones.

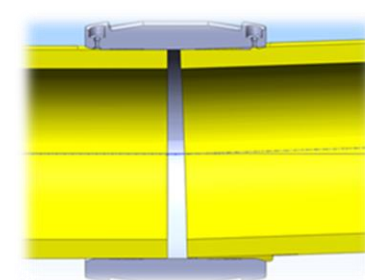
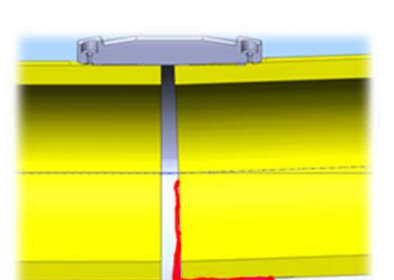
### Pipe End Mis-Aligned or Binding

Electrofusion Joint assemblies must be in a straight, stress-free, and non-binding orientation during the fusion process. Unrestrained and/or unsupported pipe and joint assemblies create stresses in the fusion zone. The weight of the pipe, the fittings and other heavy system components, must remain supported and aligned to ensure that the area being fused stays straight, stable, immobile, and free of external stresses until the cooling time has been completed.

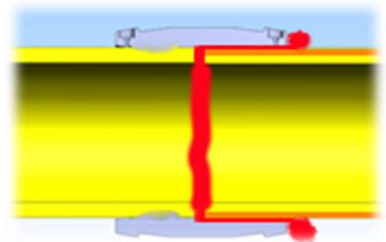
### Unscraped or Improperly Scraped Pipe Surface

The #1 cause of all Electrofusion Joint Assembly Failures is improper Pipe Surface Preparation. If the surface of the pipe has not been peeled, or it has been improperly peeled, and virgin resin is not exposed in the fusion zone; the oxidation layer on the pipes surface is enough to create an impenetrable barrier that will impede the necessary molecular bonding to take place. Resulting in a joint that will either leak and/or fail.

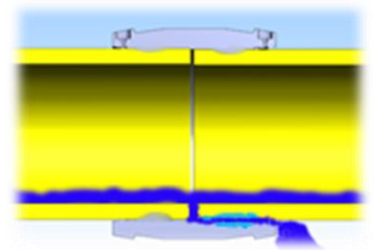
### Water Flowing in the Fusion Zone

Water flowing or trickling over the fusion coils of the EF Coupler being installed is unacceptable. Water not only creates a layer of impenetrable contamination between the pipe surface and the fitting; it also results in the water turning into steam when coming into contact with the hot fusion coil, which in turn creates a void in the fusion zone as the steam expands which can result in it becoming a leak path.

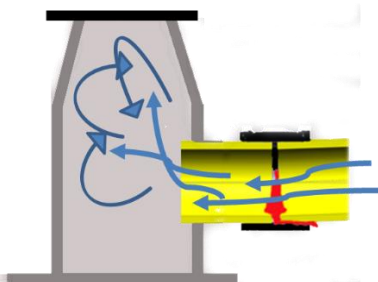
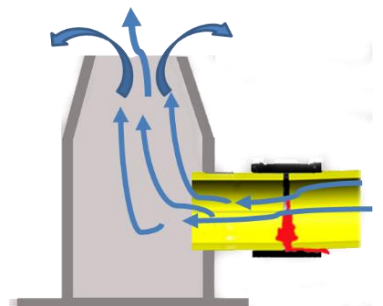
### Restricting Airflow in Vertical Applications

When fusing an EF coupler into, or part of a vertical application, you must take steps to restrict airflow through the joint assembly. The Fusion Technician on-site must also ensure that the EF joint is correctly assembled, not short stabbed, mis-stabbed or in a binding situation. Heat generated in the fusion zone can become accentuated if the molten material escapes and is exposed to an increase in airflow.

**You must take steps to minimize the potential increase in airflow through the fusion area by covering the opening with a tarp or piece of plywood to avoid creating a "rocket stove" effect.**
